## System Control Center OIL/PCB Discharge Report

# Technical Memorandum

To: Portland General Electric (PGE)  
From: Susan Garland, URS  
Date: December 6, 2011  
Subject: Willbridge Substation Stormwater Drainage Assessment

## WILLBRIDGE SUBSTATION DRAINAGE

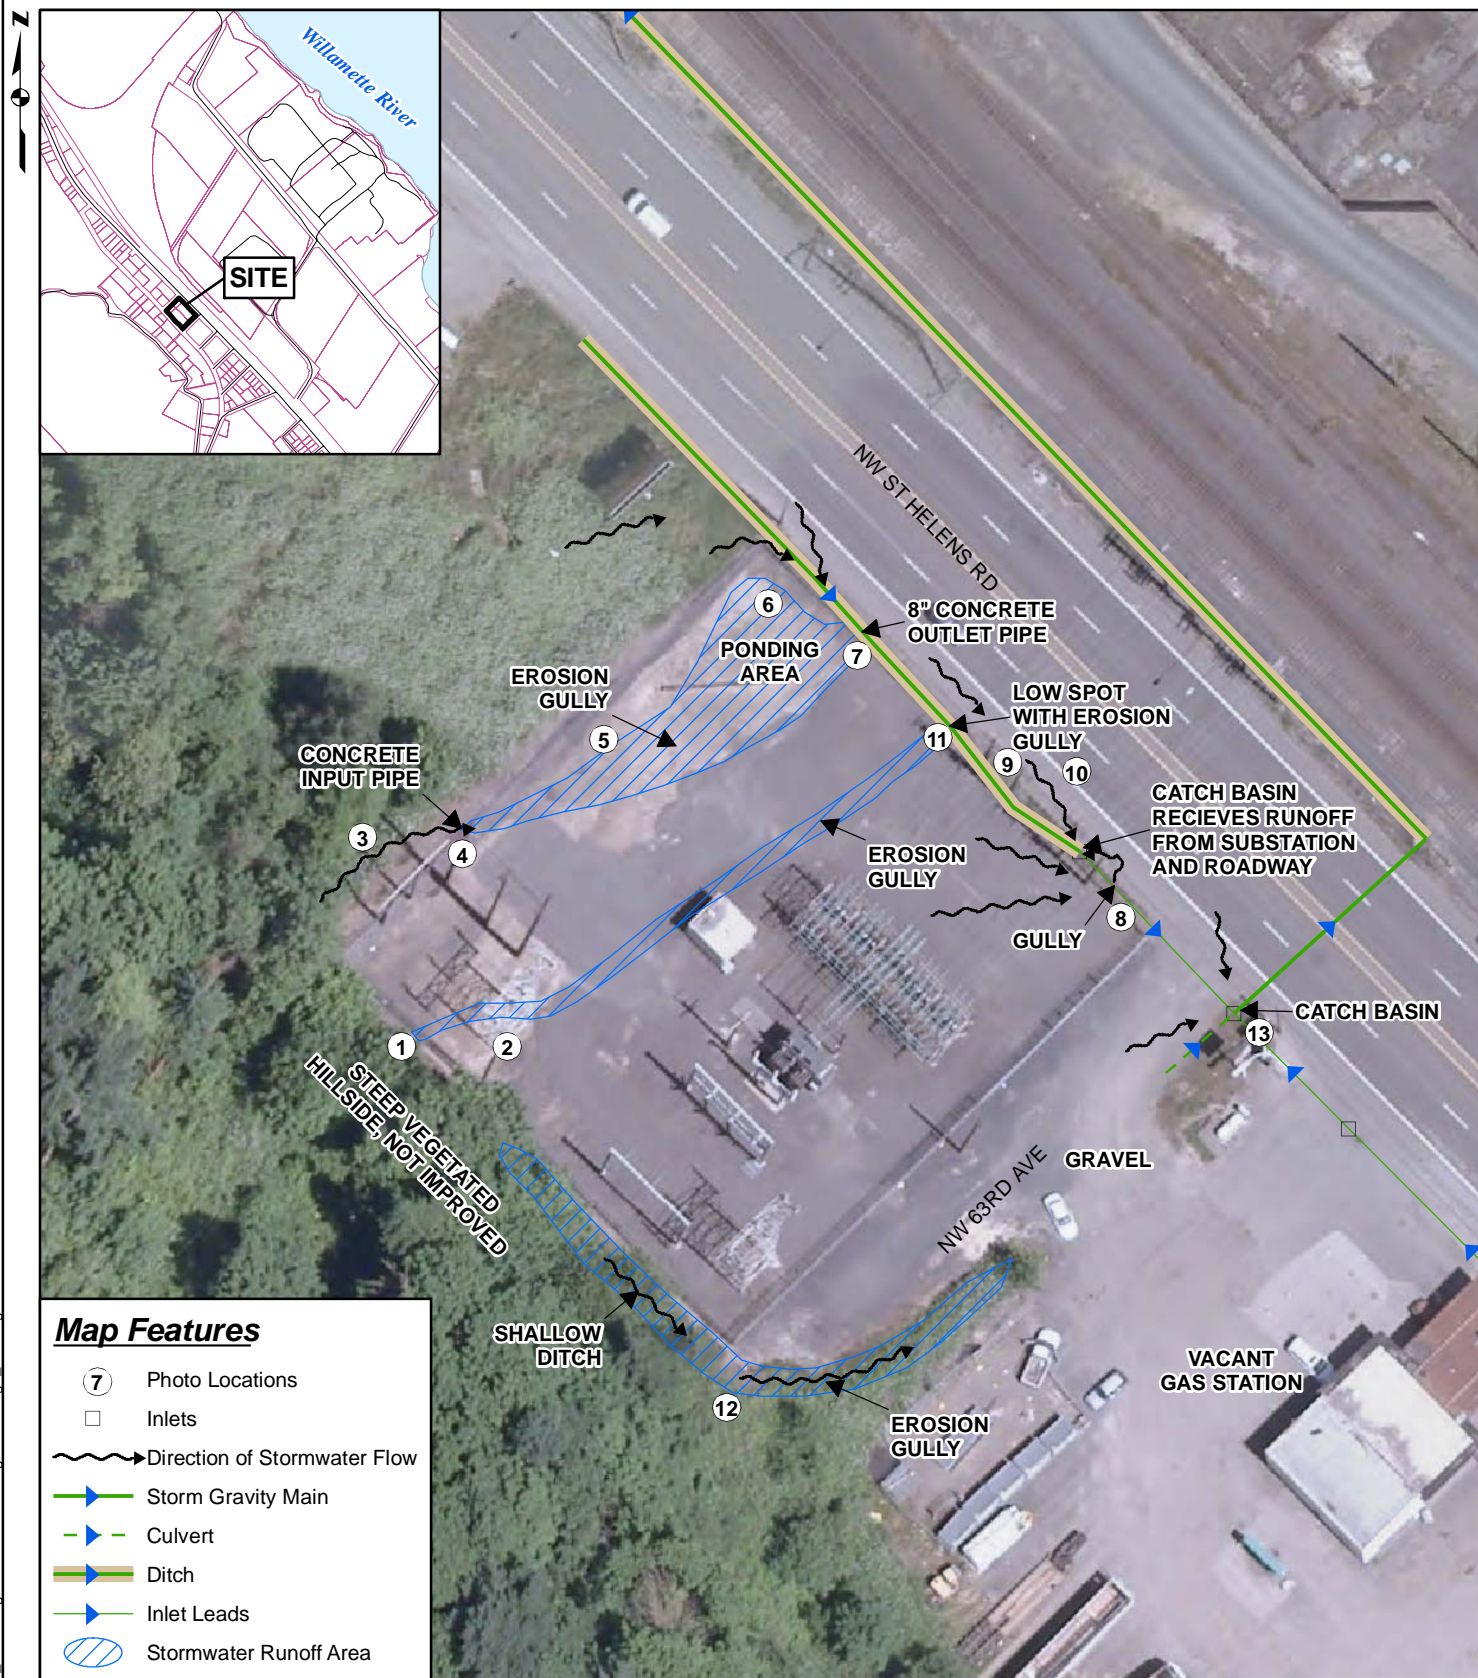
**FIGURE 1**

As shown in Figure 1, the Willbridge Substation occupies a graveled area at the foot of a steep, vegetated hillside, located on the west side of NW St. Helens Road. City and County maps depict a public right-of-way, Willbridge Avenue, adjoining the substation on its uphill, northwest side, but this right of way is not graded or cleared of trees.

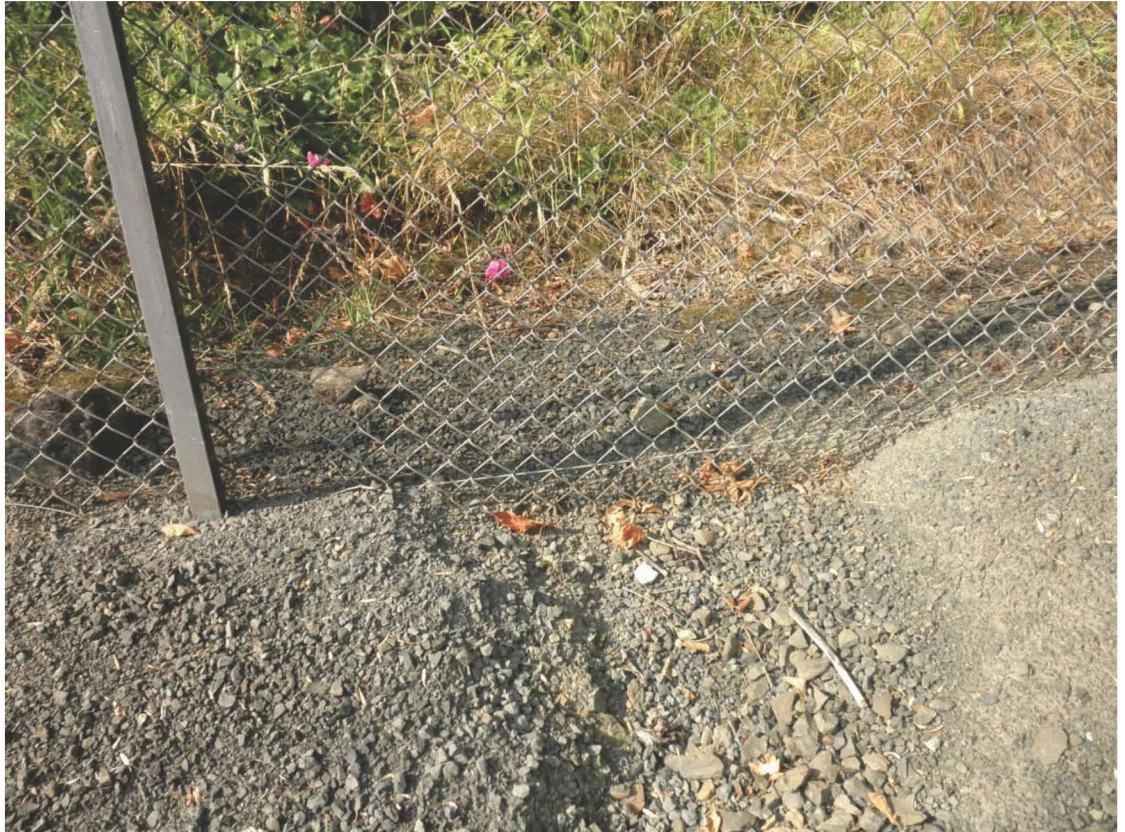
1

On the southwest edge of the substation, a small gully on the adjacent hillside defines a surface water flow path that continues onto the substation through a low spot under the substation fence (Photo 1). From here, the shallow gully continues across the substation to a low spot (Photo 11) along the northeast edge of the substation property, where it enters an ODOT storm ditch (Photo 9) between the substation and St. Helens Road. During the November 16<sup>th</sup> site visit, small amounts of water were discharging from this point into the ditch, but there was no surface water flowing onto the substation from the hillslope.

Low spot in uphill  
substation boundary  
where stormwater  
drainage is entering from  
the hillside.

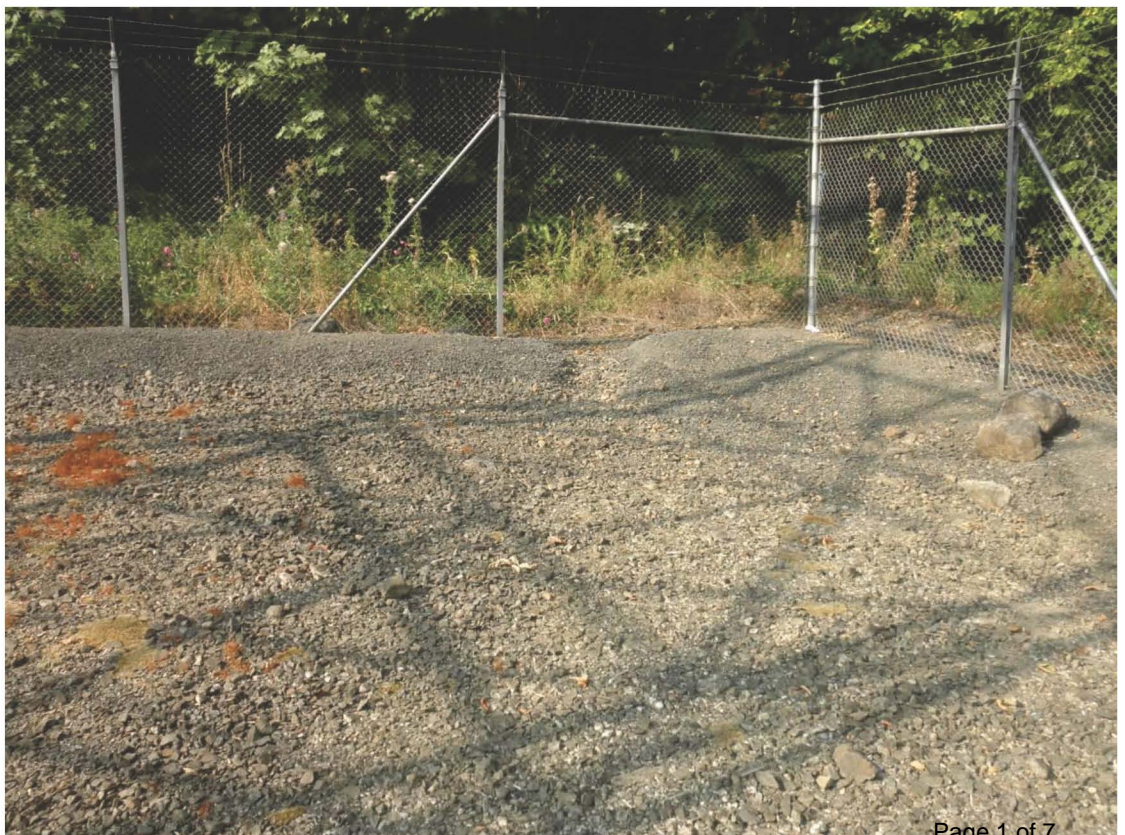
2

Erosion gully showing that  
hillside drainage is  
entering substation from  
the adjoining hillside

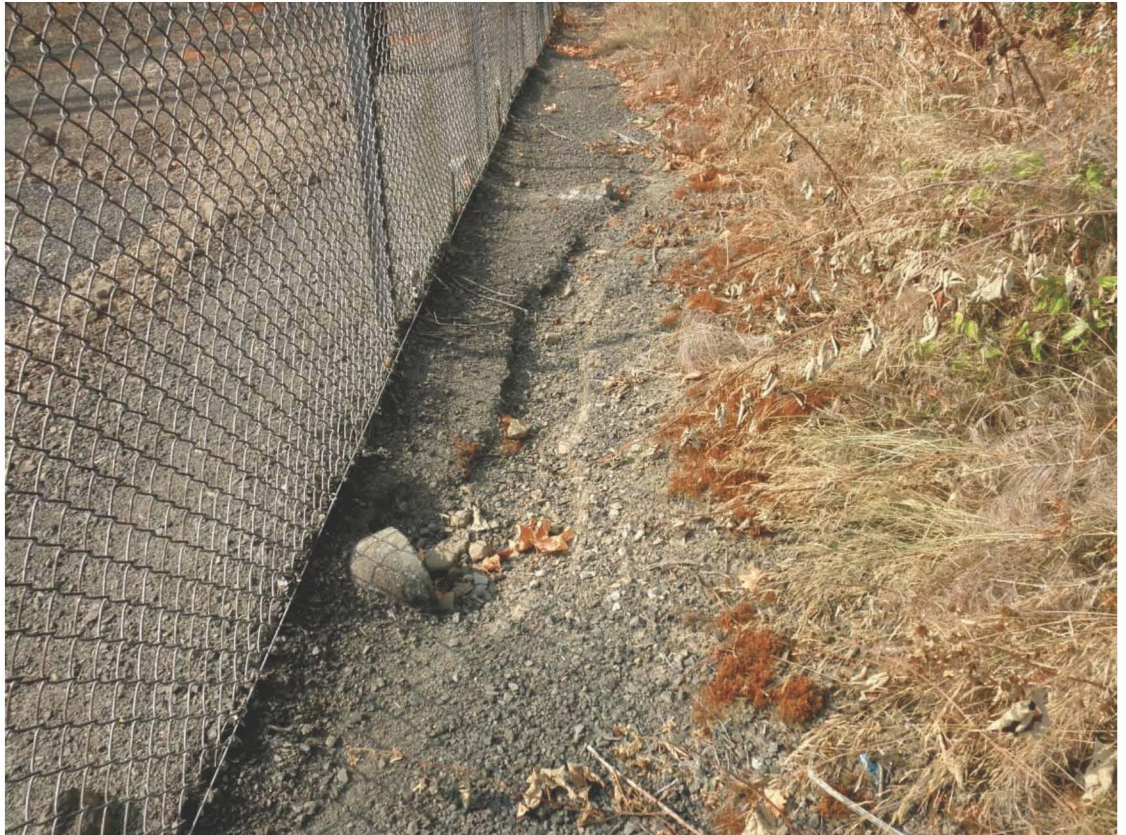
Along the northwest edge of the substation a small gully on the adjacent hillside defines a surface water flow path (Photo 3). The flow path continues through an eight-inch-diameter concrete pipe under the substation fence and onto the substation (Photos 3 and 4). The flow path continues northeast as a prominent gully to the northeast corner of the substation where an eight-inch-diameter concrete pipe (Photo 7) connects the flow path to the ditch between the substation and St. Helens Road. Sediment deposits immediately upslope of the pipe (Photo 6) indicate that some ponding of water and sediment deposition occurs before the water discharges through the pipe to the ditch. Ponding occurs because the pipe invert elevation is higher than the ponding area, and the pipe is partially filled with soil and gravel which further increases the effective invert elevation of the pipe. However, sediment-coated gravel within the pipe and at its outlet to the ditch (Photo 7) indicates that sediment is also transported to the ditch. During the November 16<sup>th</sup> site visit, no water was discharging from this pipe and there was no surface water flowing onto the substation from the hillslope gully.

Looking uphill from the northwest substation fenceline, a gully showing that drainage from the northwest of the substation is entering the property through a concrete inlet pipe.

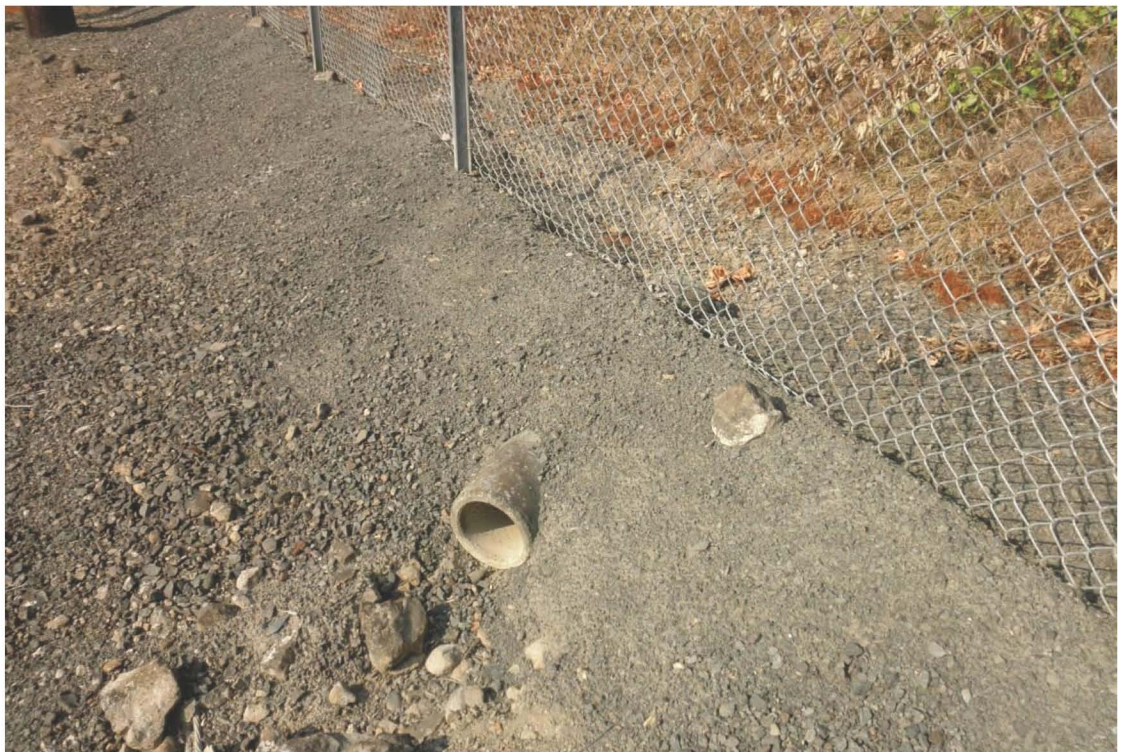
4

From inside of the substation fence, the concrete pipe bringing drainage in from the hillside.

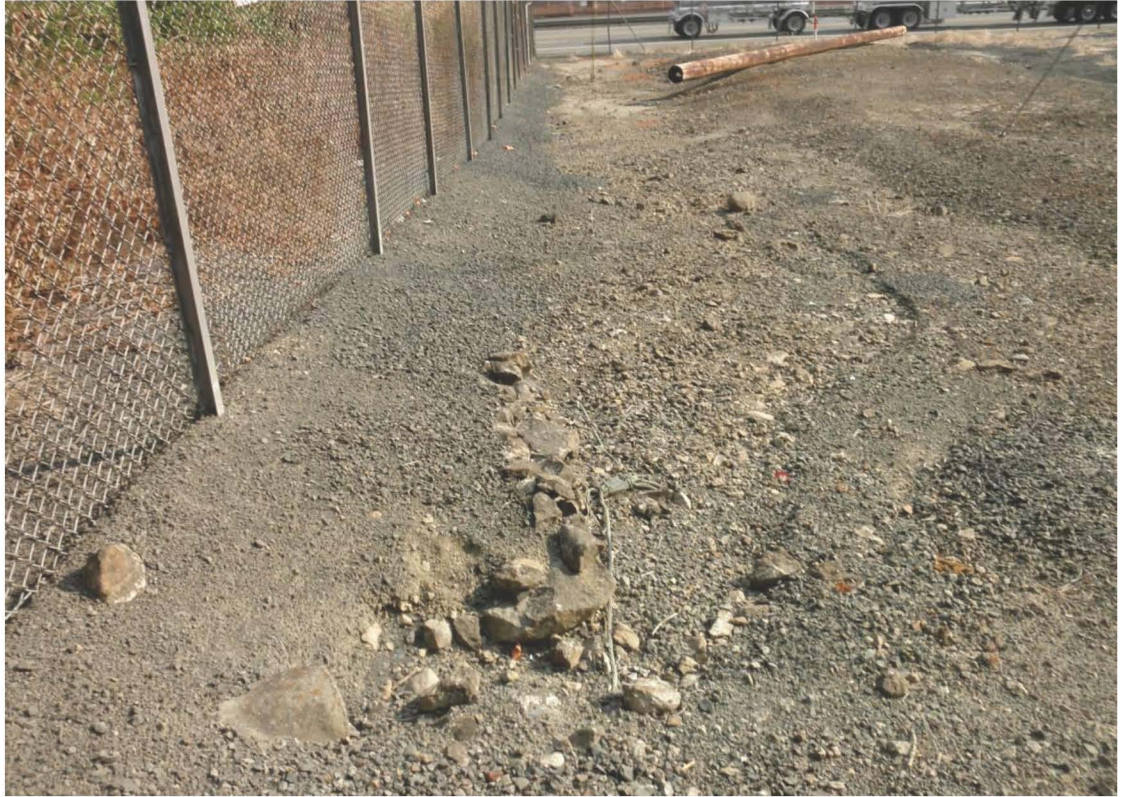
5

Looking downhill from the inlet pipe, a prominent erosion gully leading toward NW St. Helens Road

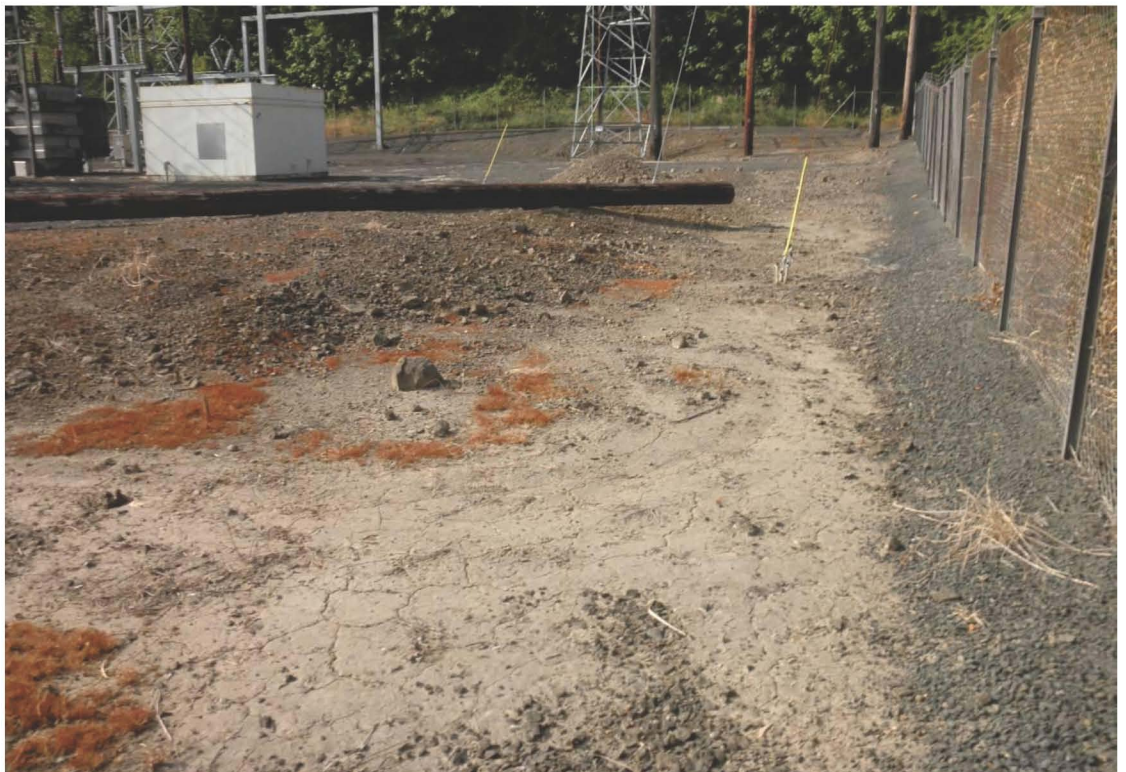
The Willbridge parcel general slopes northeast toward St. Helens Road, but the ground surface is irregular, and the north end of the property has both gullies and elevated areas consisting of gravel piles. Photo 6 in Appendix A shows surface soil cracks that are indicative of surface ponding. As depicted on Figure 1, several prominent gullies cross the site, indicating lateral surface flow across the substation. During the November 16 rain event, surface ponding occurred in several areas at the south end of the site, most prominently in the southeast corner. Hillslope drainage enters the substation site from two locations, adding stormwater volume and channelizing flow conditions.

Silt deposits and drying cracks on the ground surface in the foreground show evidence of ponding in the north corner of the substation

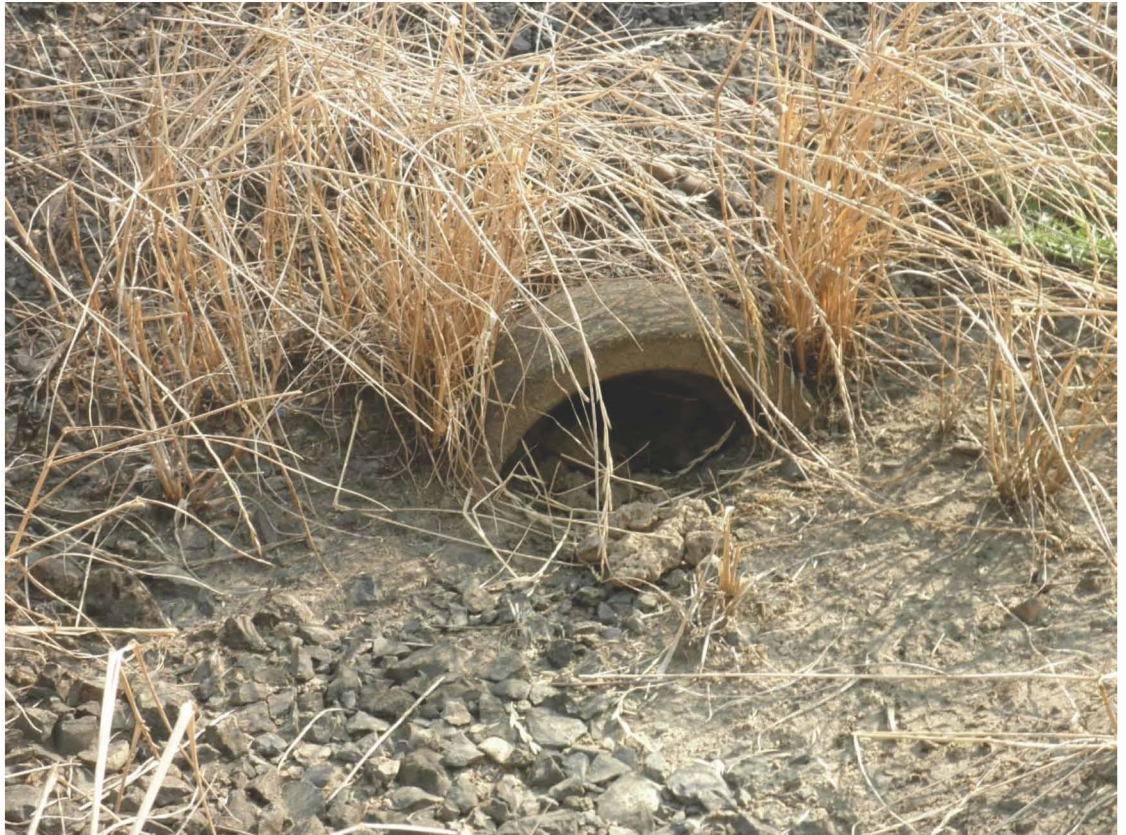
**Photo No.**      **Date:**  
7

Outlet pipe at base of ponding area leading to a roadside ditch, and showing evidence of entrained gravel and sediment transport.

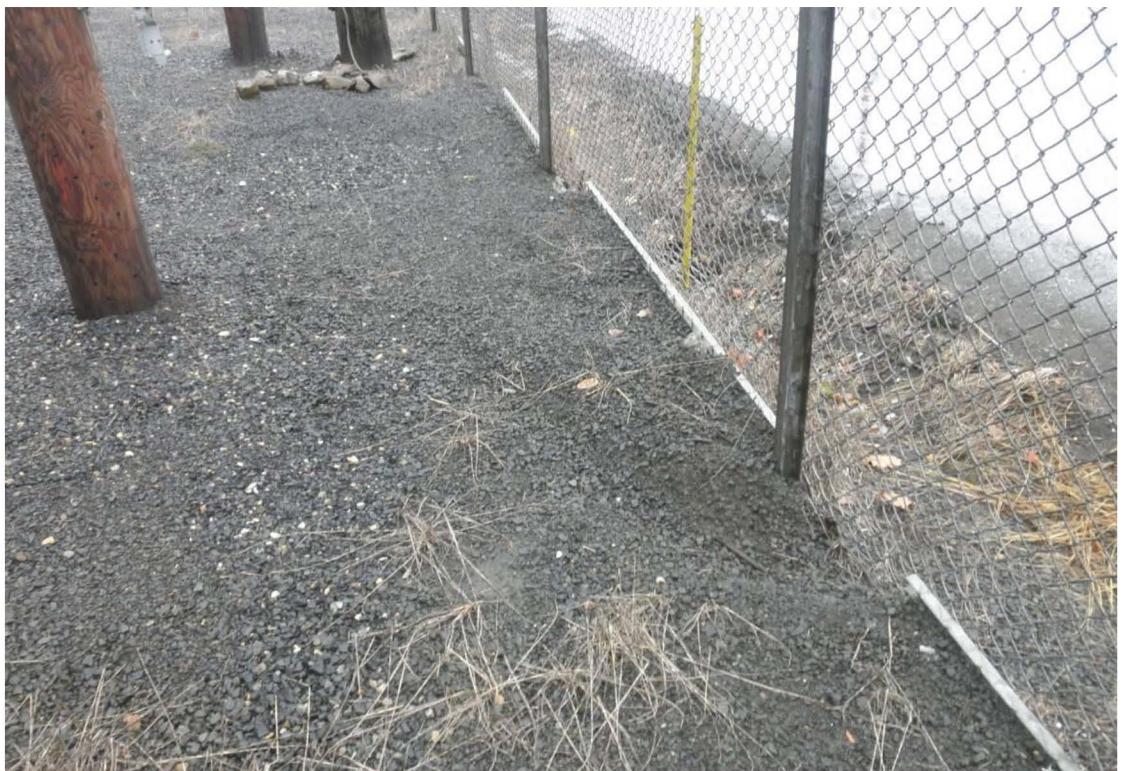
**Photo No.**      **Date:**  
8      11-16-11

In addition to the two discharges to the road-side ditch described above, a third point of discharge from the substation to the adjoining ditch (Photo 8) is located near the substation's southeast corner. The area did not have the prominent gullies or sediment deposits noted along the other flow paths described above, and hillslope run-off does not appear to contribute to this discharge point. No discharge was flowing from this point during the November 16<sup>th</sup> site visit.

Low spot at east end of substation with evidence of surface erosion into the ditch along St. Helens Road.

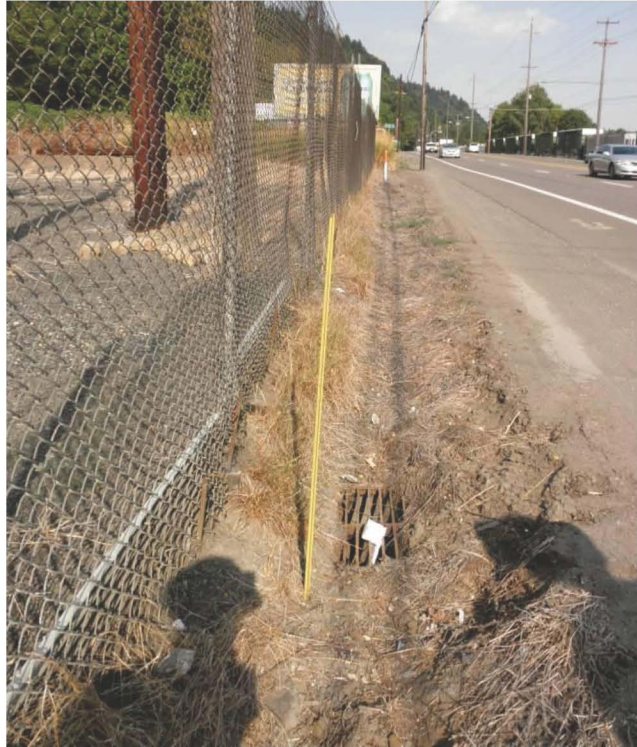
**Photo No.** 9      **Date:** 09-08-11

Ditch and catch basin located between Willbridge Substation and NW St. Helens Road.

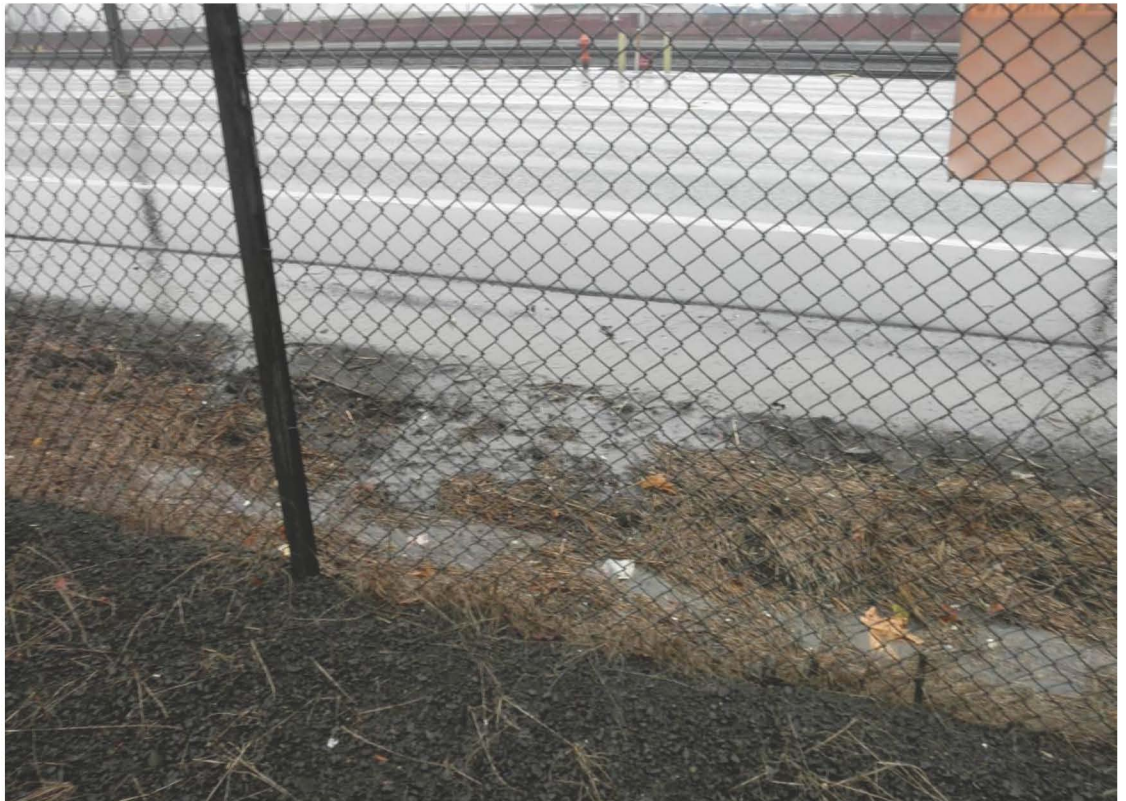
**Photo No.** 10      **Date:** 11-16-11

Ditch and catch basin receiving stormwater from St. Helens Road during November rain event.

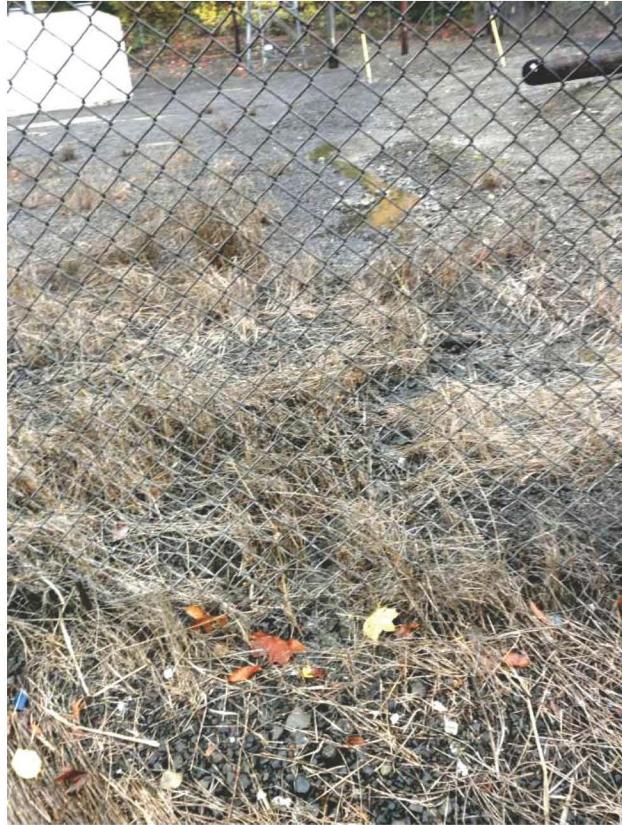
**Photo No.**      **Date:**  
11                  11-16-11

Surface outlet of central  
erosion gully under fence  
and into roadside ditch.

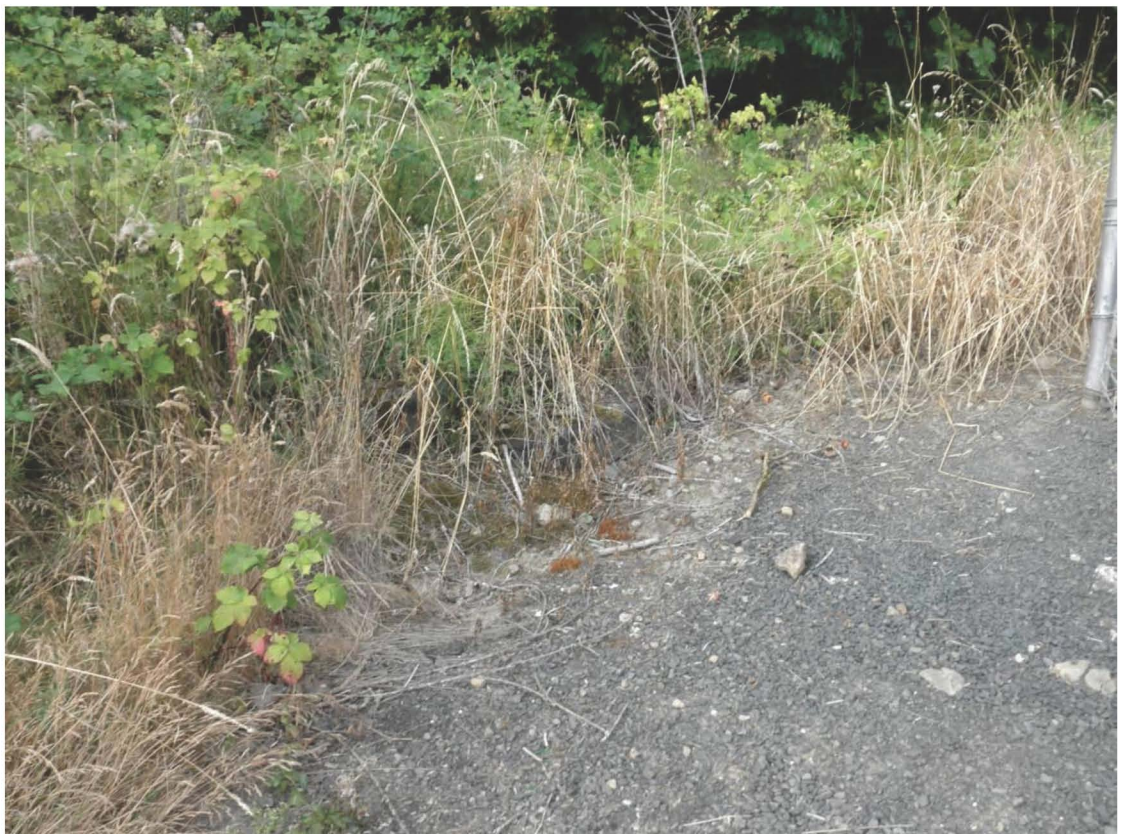
**Photo No.**      **Date:**  
12                  09-08-11

On the southwest side of the substation, a shallow ditch (Photo 12) is located uphill of the substation and diverts hillside run-off around the substation and onto the gravel right-of-way of NW 63<sup>rd</sup> Avenue. Runoff from the substation does not commingle with this hillslope runoff.

The south section of the  
hillside above the  
substation is diverted in a  
shallow ditch and flows  
onto the gravel right-of-  
way of 63<sup>rd</sup> Avenue.

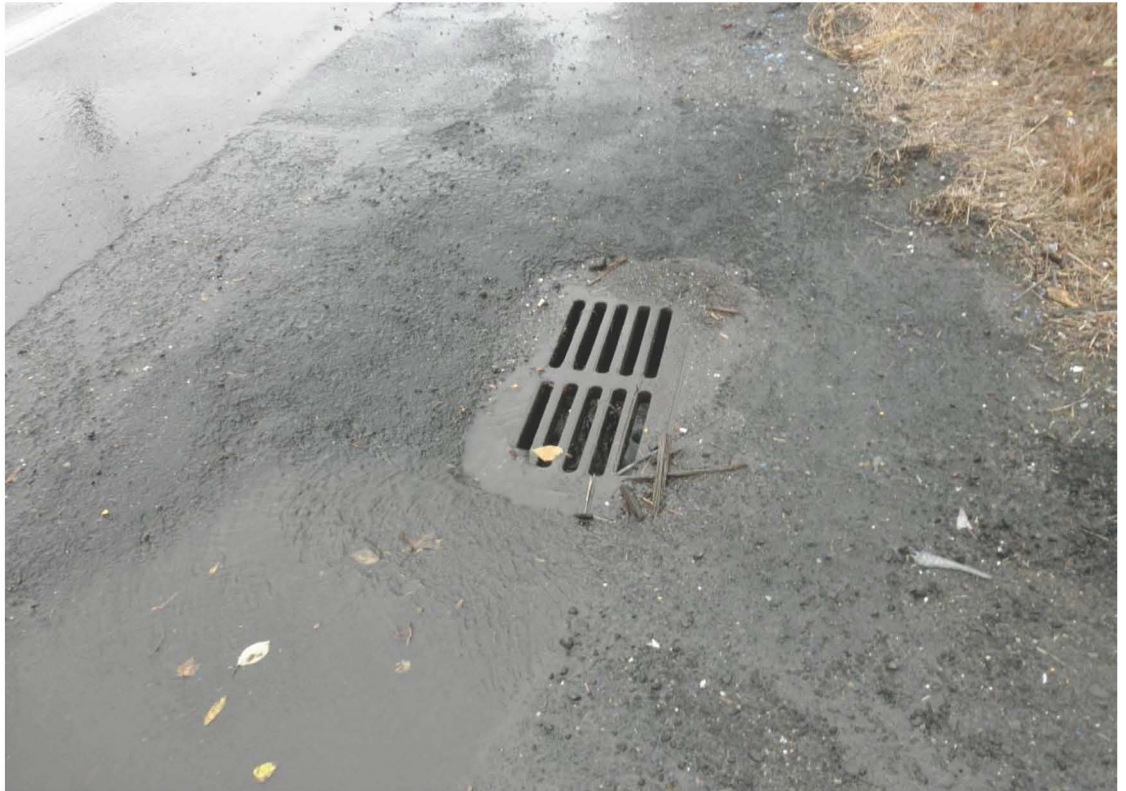
**Photo No.**      **Date:**  
13              11-16-11

A catch basin east of the Substation receives the remaining runoff from NW St. Helens road and the runoff from NW 63<sup>rd</sup>.
